APOLLO 17

30-DAY FAILURE AND ANOMALY LISTING REPORT

APOLLO 17
30-DAY FAILURE AND ANOMALY LISTING REPORT

PREPARED BY
Mission Evaluation Team

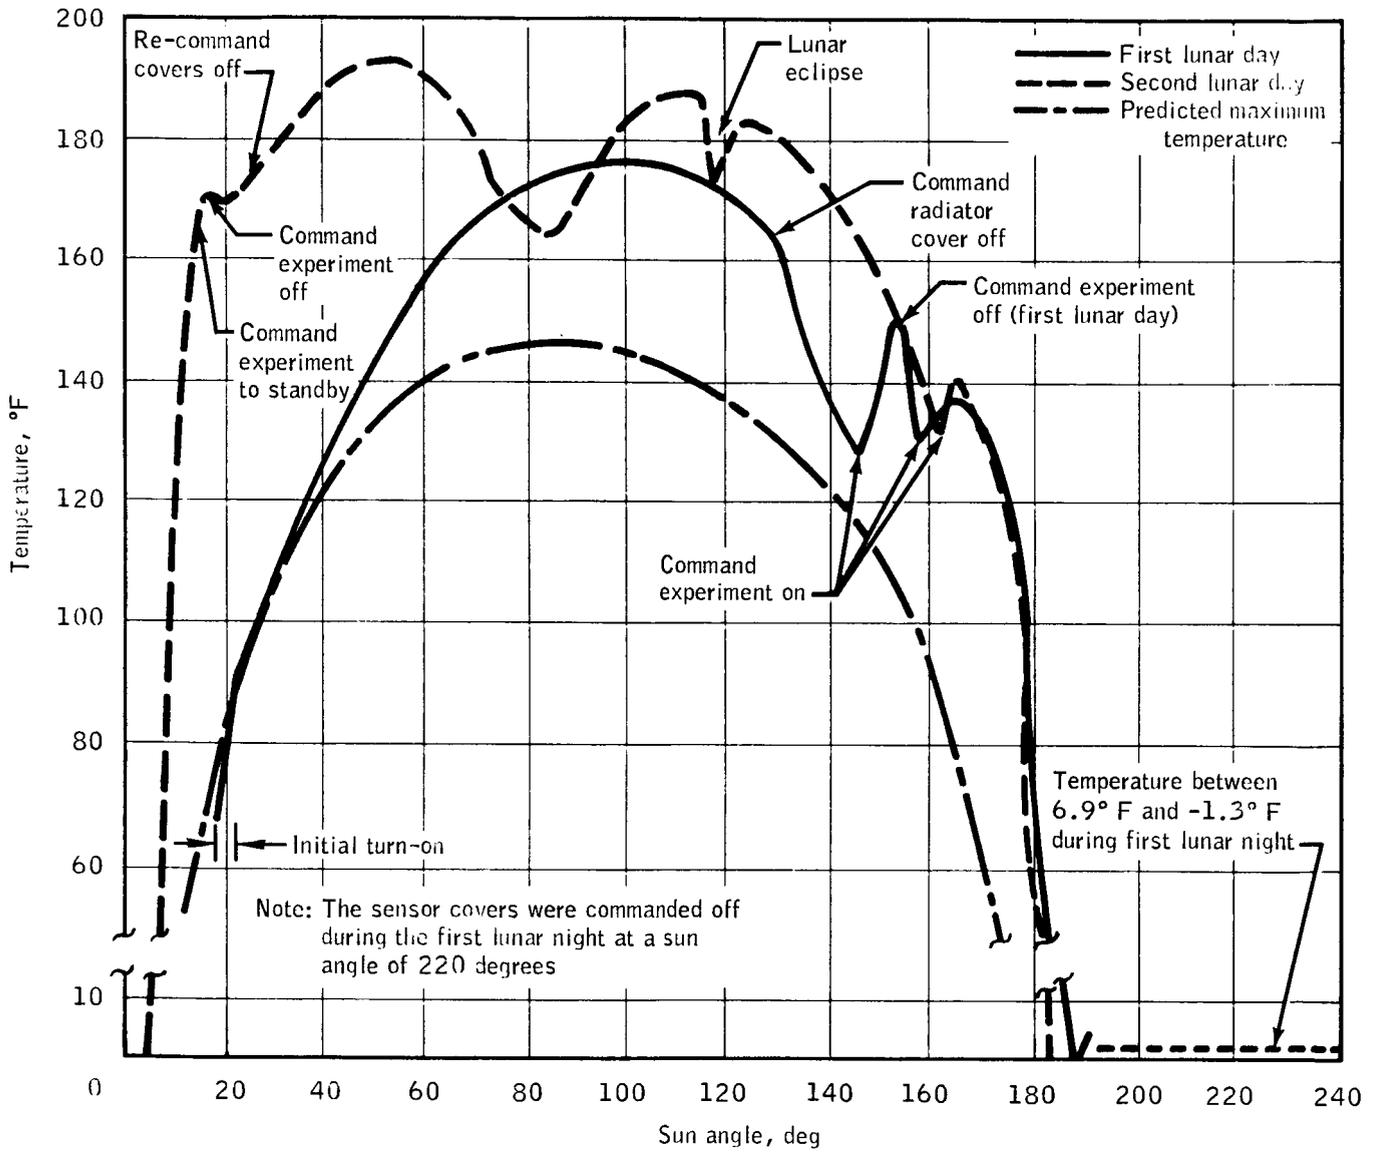
Figure 5-4.- Lunar ejecta and meteorite experiment temperature data.

The temperature of the lunar ejecta and meteorite experiment was higher than predicted during the first and second lunar days (fig. 5-4). The high temperatures occurred with all combinations of experiment modes: on, off, and standby, with all dust covers on, with only the sensor covers on, and with all covers off. Whenever the experiment was in the "operate-on" mode, the science data indicated normal operation of the experiment. The maximum allowable temperature for survival of the electronic components has not been exceeded; however, it was necessary to command the experiment from "operate-on" to "off" at a sun angle of about 153 degrees during the first lunar day and at a sun angle of about 16 degrees during the second lunar day. Following sunrise of the second lunar day, the temperature rose from 0° F at 0° sun angle to about 168° F at 15° sun angle (fig. 5-4). The instrument was commanded to standby and then to off because the temperature continued to rise. In the off mode, with no power to the instrument, the temperature rise rate was lower.

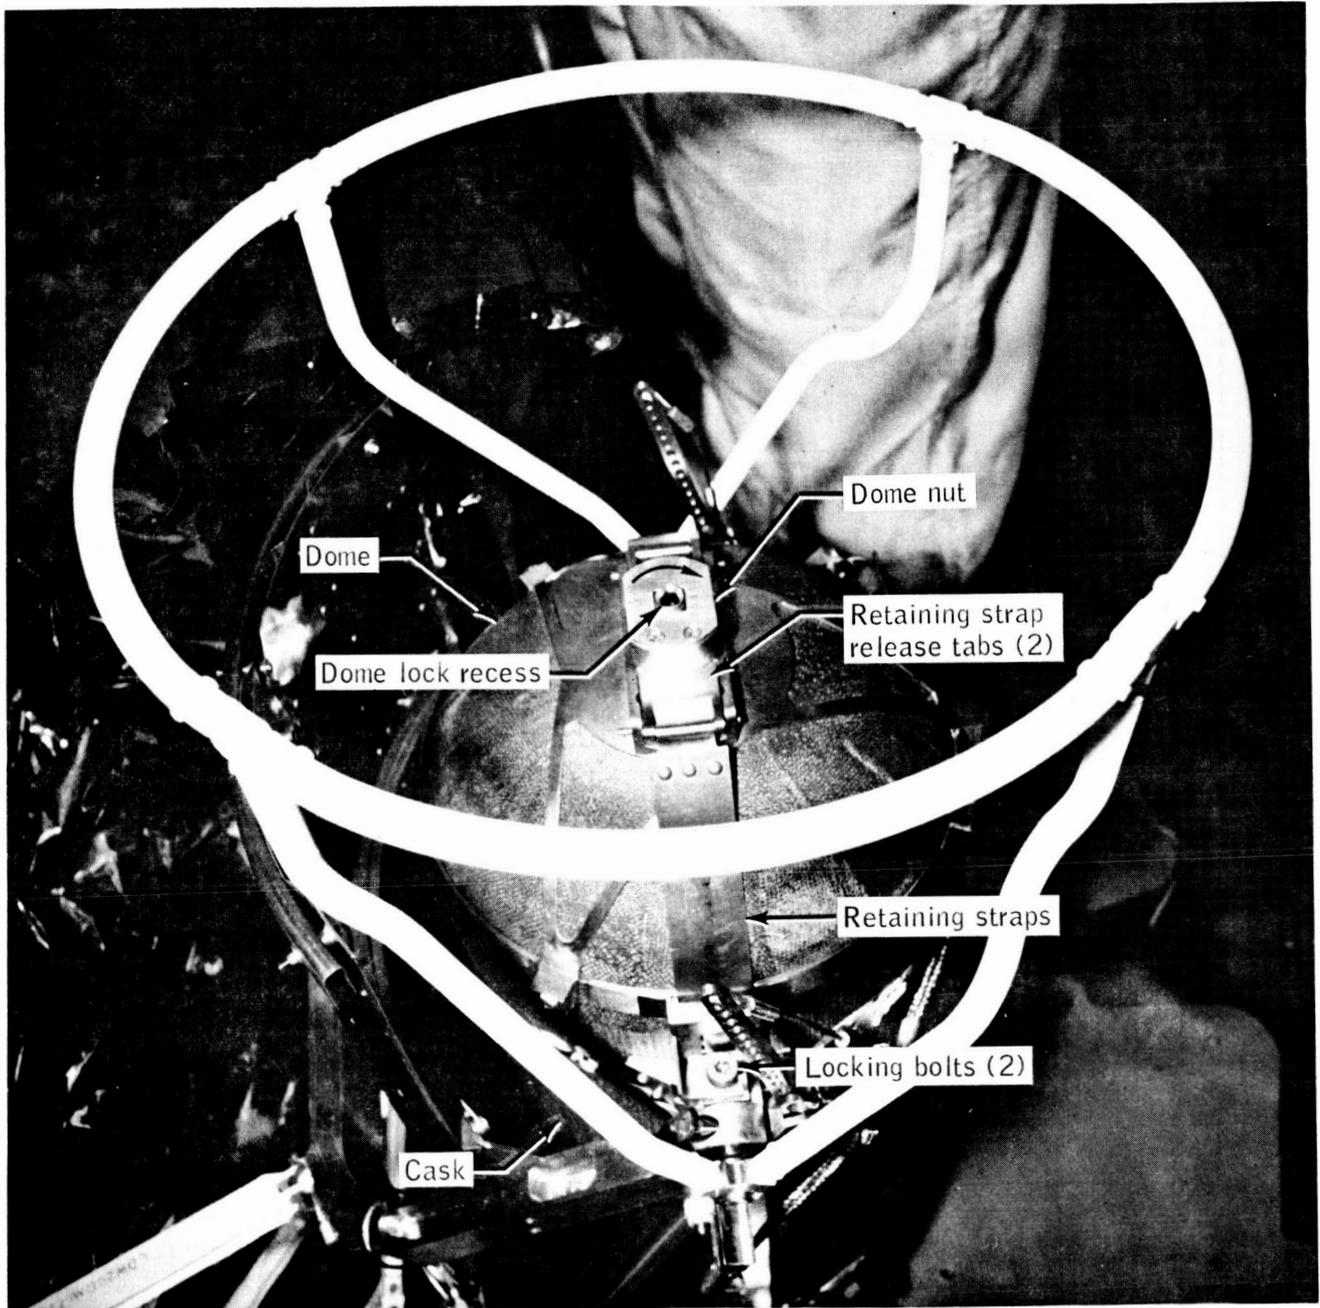
Figure 5-5.- Fuel cask dome release mechanism.

The socket on the removal tool can engage the nut on the dome before the pins on the tool lock into the recess in the dome (fig. 5-5). The Lunar Module Pilot did not verify that the pins were locked. In this configuration, rotating the tool clockwise will rotate the nut on the dome. A 90-degree rotation of the nut releases the dome retaining straps, as noted by the crew. This release allows the dome to rotate when the tool is rotated another 60 degrees, thus disengaging the threaded dome/cask interface. However, with the pins not locked into the dome recess, the dome could be cocked, but not withdrawn. The dome was easily wedged off the cask with the hammer. The sequence can be duplicated with either broken pins or by incomplete insertion and locking of the tool pins.

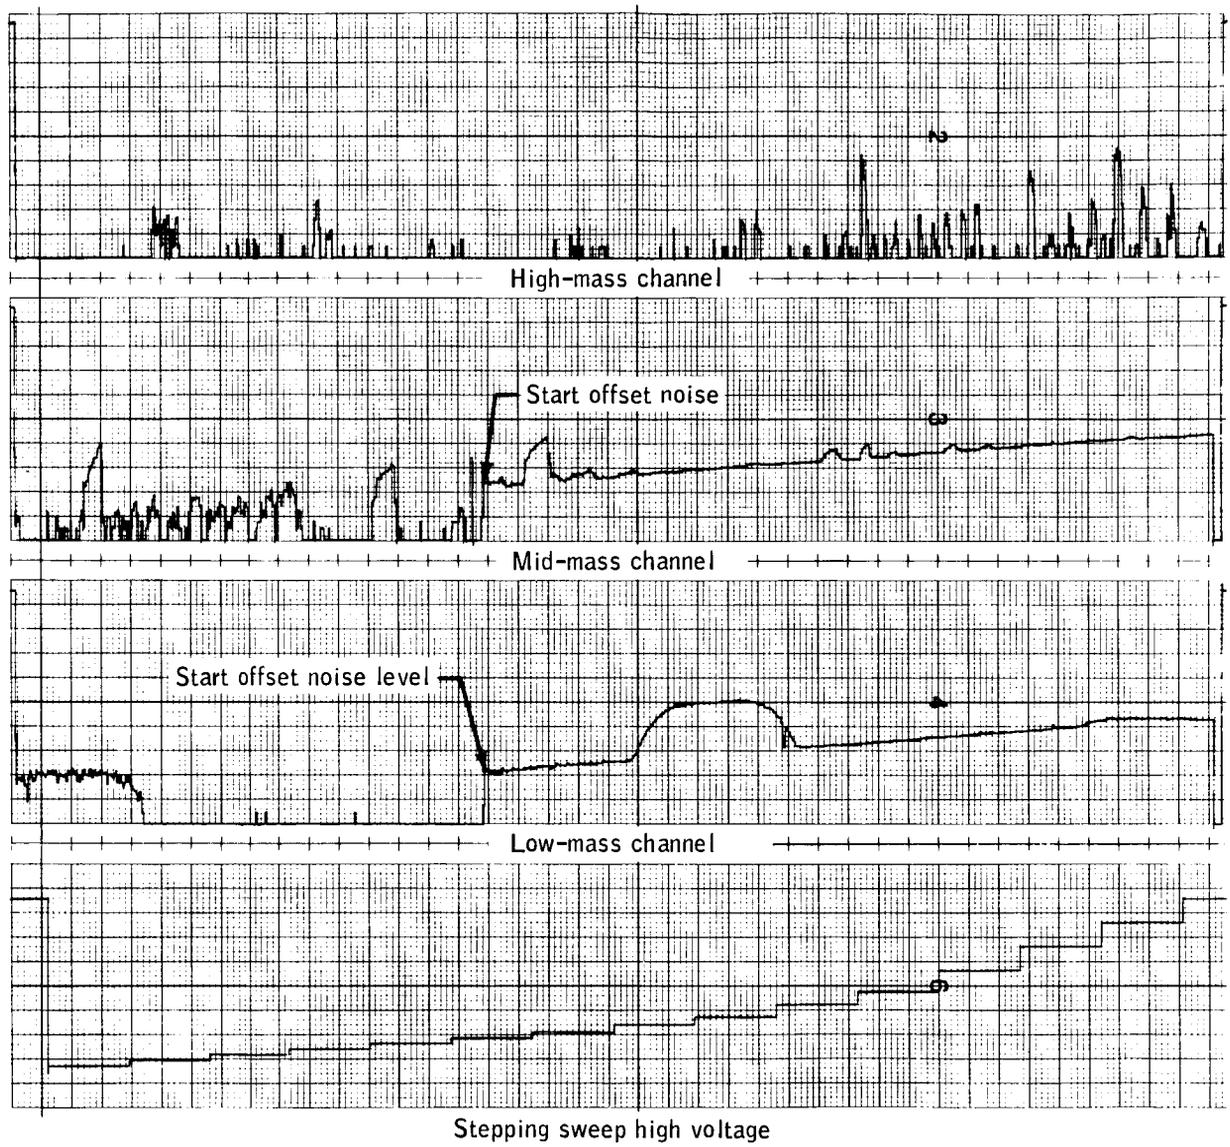
Figure 5-6.- Zero offset in lunar atmospheric composition experiment data.

A zero offset was noted in part of the lunar atmospheric composition experiment data on the mid-mass and low-mass channels (fig. 5-6). This offset was the result of background noise.

Commanding the sensor ion sources on and off, or the sensor electron multipliers on or off does not affect the condition. The presence of the offset is, however, affected by the voltage level to the sensors. The possibility of cross-coupling between unshielded high voltage wires and unshielded collectors in the sensor package is being investigated.

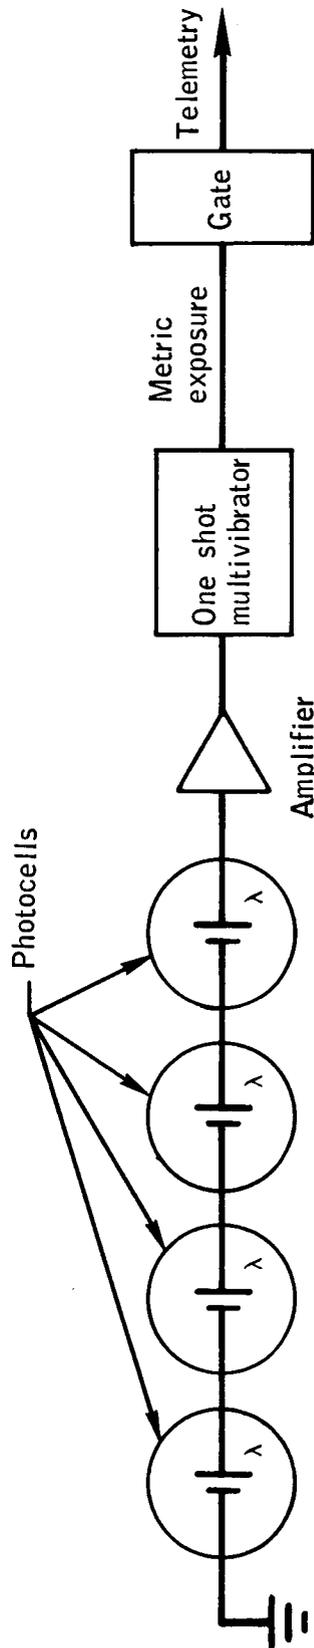
Figure 6-2.- Light sensor circuitry.

The pulse is generated by a light sensor and associated amplifier and a one-shot multivibrator (fig. 6-2). The light sensor consists of four photo diodes, with one near each edge of the 4-1/2 by 4-1/2 inch picture format (fig. 6-3). All four diodes are connected in series.

The test strip indicated that the film had been properly exposed, thus indicating that the light sensor circuitry had indeed experienced a threshold shift. This shift could have been the result of a photo diode failure or a change in the performance of the amplifier, the one-shot multivibrator, or the circuitry between these two elements.

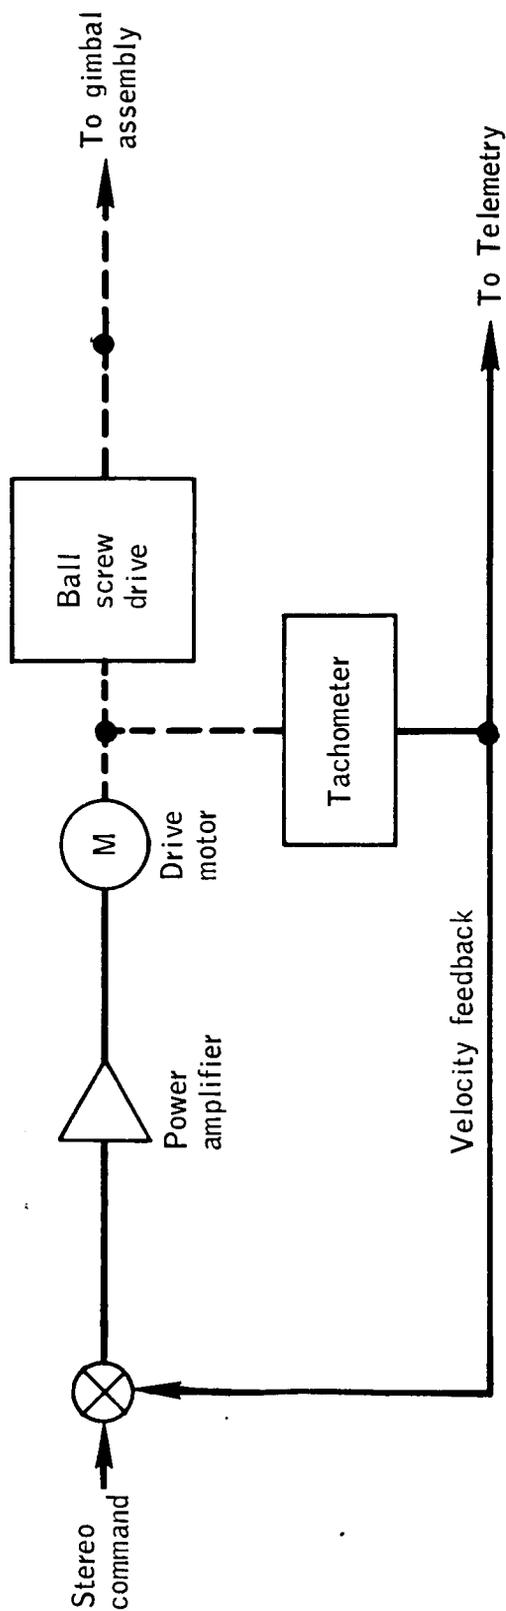
Figure 6-4.- Panoramic camera gimbal drive system.

This inability to gimbal the lens system was apparently the result of a failure in either the gimbal drive motor or the electrical circuitry that provides power to the motor. It is most likely that the motor failed, since its brushes are limited life items.
